Montana Department of  
**ENVIRONMENTAL QUALITY**

**Subject: May 5, 2006, Compliance Evaluation Inspection - Asarco East Helena Plant**

**FIELD INVESTIGATION REPORT**

**SITE:** Asarco - East Helena Plant

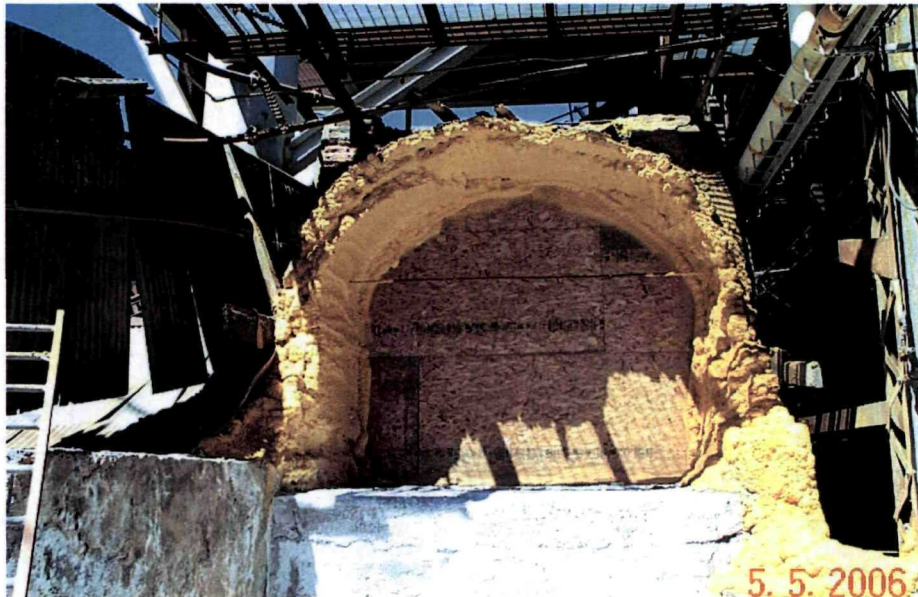
Standing in the Blast Furnace Flue looking west at the bulkhead sealing off the flue from the #1 Blast Furnace to the Dross Plant.

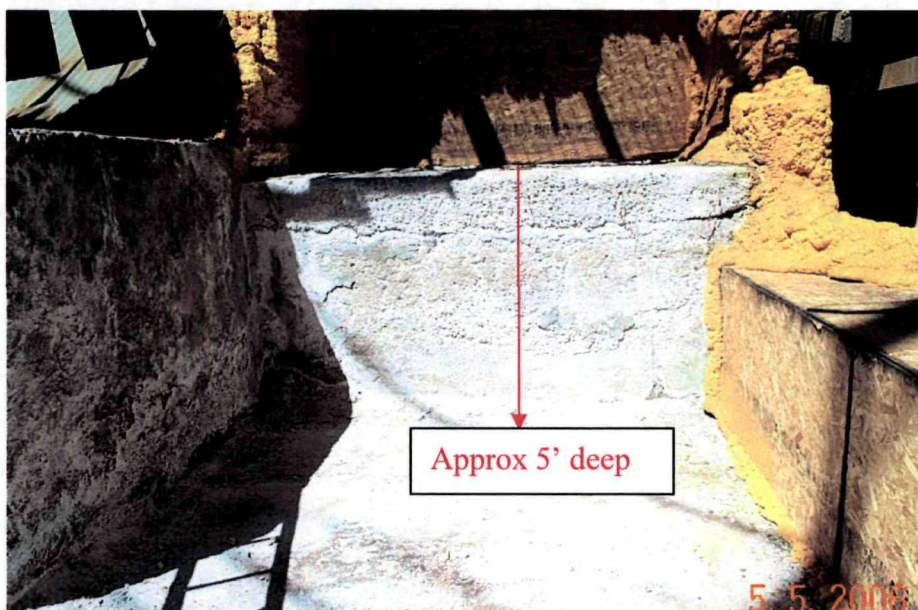
PHOTO #: ASARCO\_06125-002  
PHOTOGRAPHER: Iver L. Johnson  
PHOTOGRAPHER (int.) Iver L. Johnson  
CAMERA: Kodak DC5000 Zoom Digital Camera  
FILM TYPE: N/A  
NEGATIVE LOCATION: N/A  
EXPLANATION:

Looking at the eastside concrete wall that supports the roof over the #3 blast furnace slag tunnel.

The depth of the flue dust that was on top of the concrete floor is unknown. However, the distance from the top of roof over the #3 slag tunnel to the floor of the flue was approximately 5 feet.

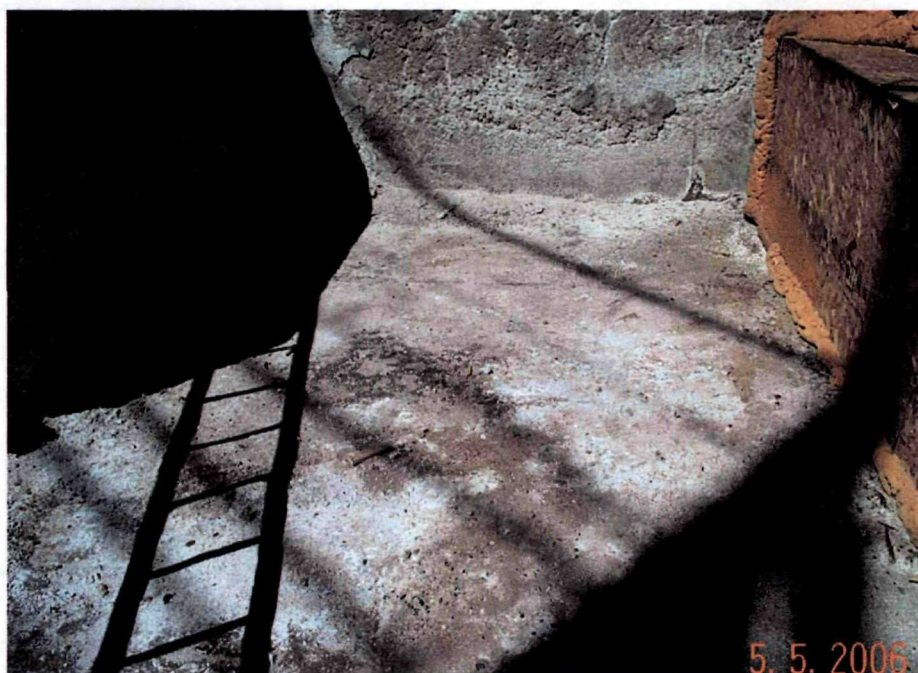
PHOTO #: ASARCO\_06125-003  
PHOTOGRAPHER: Iver L. Johnson  
PHOTOGRAPHER (int.) Iver L. Johnson  
CAMERA: Kodak DC5000 Zoom Digital Camera  
FILM TYPE: N/A  
NEGATIVE LOCATION: N/A  
EXPLANATION:

Standing on the concrete floor in the Blast Furnace Flue behind the #1 Blast Furnace process unit.

It appears that the flue area behind the entire Blast Furnace was built with a concrete floor. However, it is unknown how far the concrete floor extends beyond this area as the flue heads west towards the Dross Plant or east further along the flue itself.

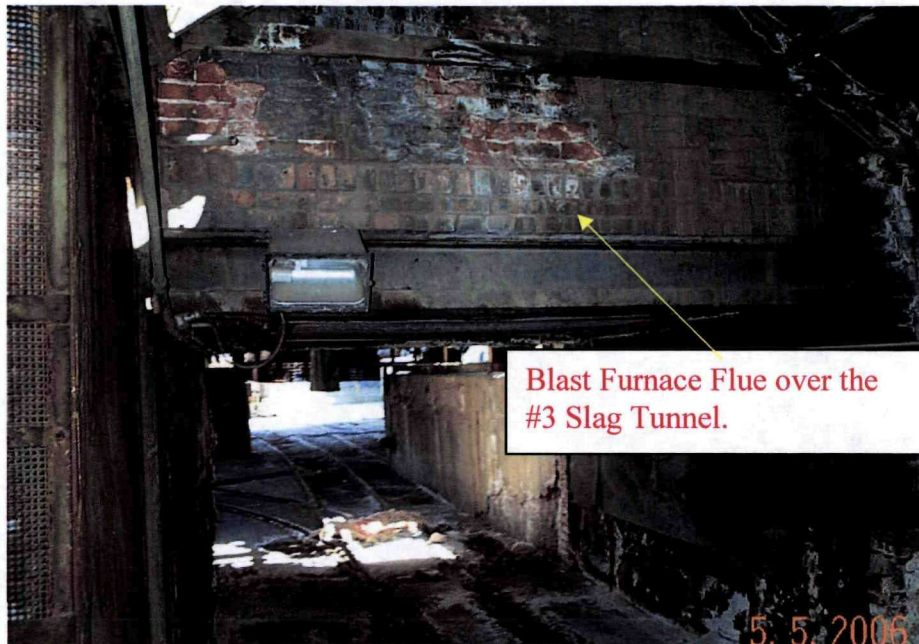
PHOTO #: ASARCO\_06125-004

Standing in the #3 Blast Furnace slag tunnel looking north at the south side and bottom of the Blast Furnace Flue as it passes over the tunnel.

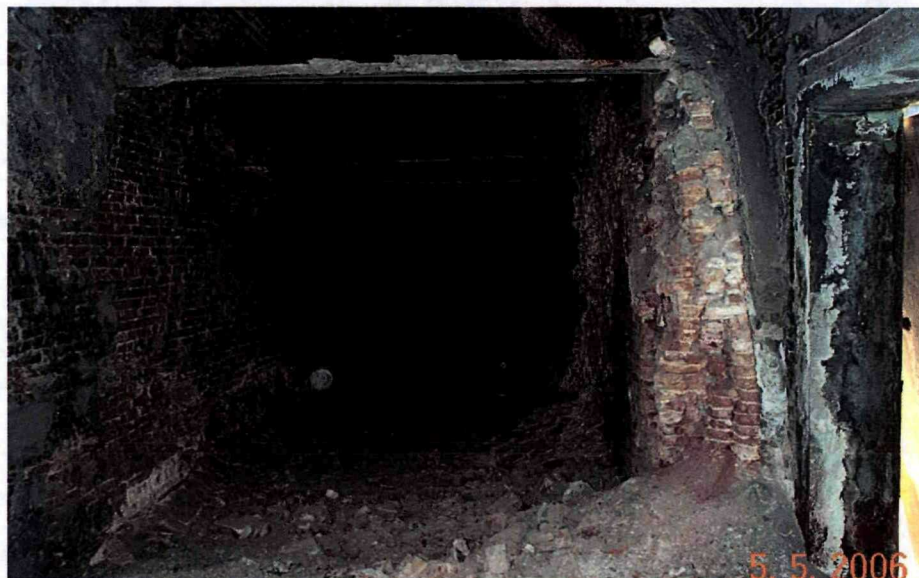
PHOTO #: ASARCO\_06125-005

Standing in the blast furnace flue looking east towards the #3 Blast Furnace west wall that goes over the #3 slag tunnel.

Note the continued deterioration of the flue. The depth of the flue dust is unknown at this location as is the composition of the flue floor.

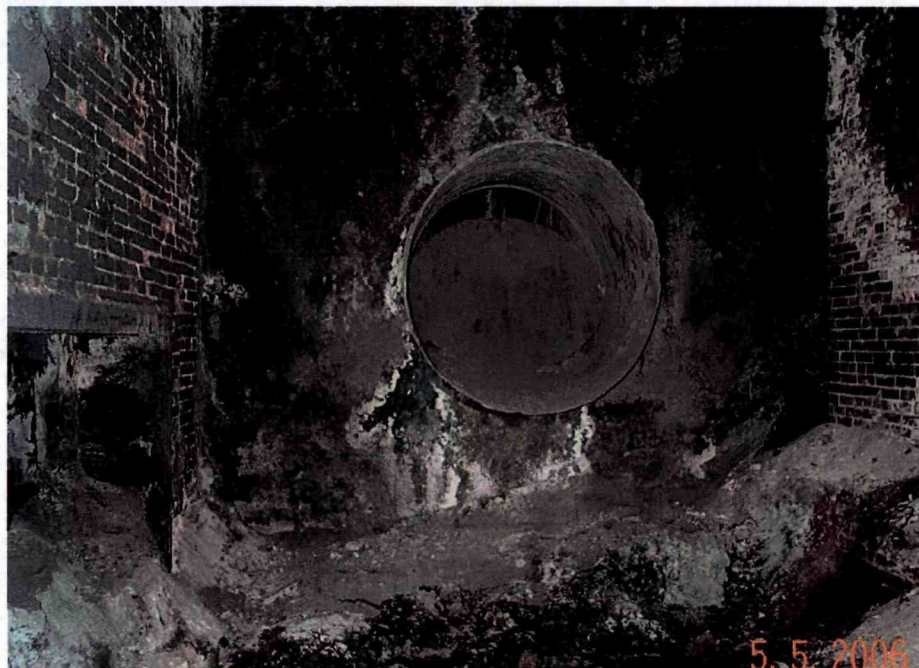
PHOTO #: ASARCO\_06125-006

Standing in the same location in the flue, as described in the photo above, looking west towards the Dross Plant Vent Duct that leads into the Blast Furnace Flue.

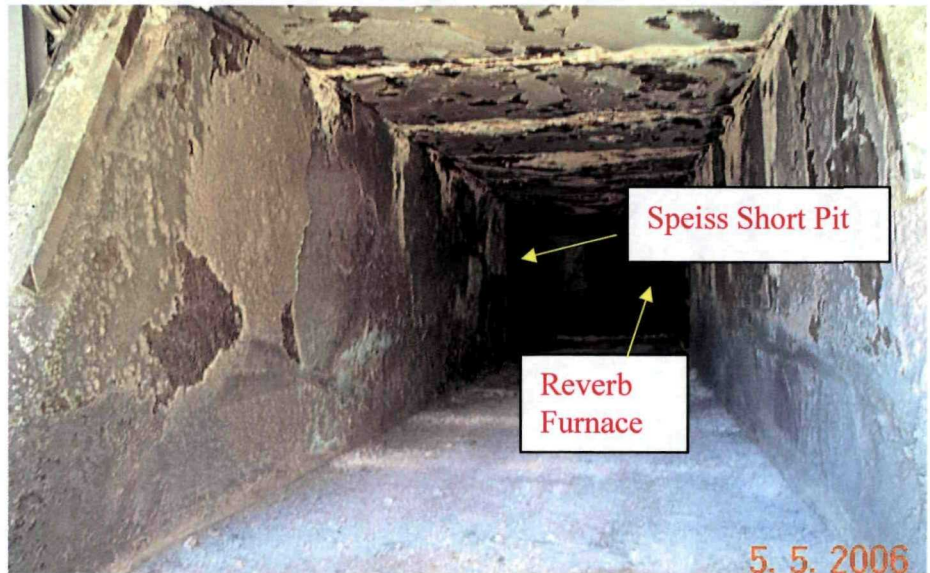
PHOTO #: ASARCO\_06125-007

Standing outside the Speiss (Long) Pit that leads into the Dross Plant. At the end of the pit is the opening into the Reverb furnace in the Dross Plant. If one were to take a left turn at the end of this pit, it leads to the Speiss (Short) pit.

Note: The floor and the walls of the Speiss Pits are made of concrete.

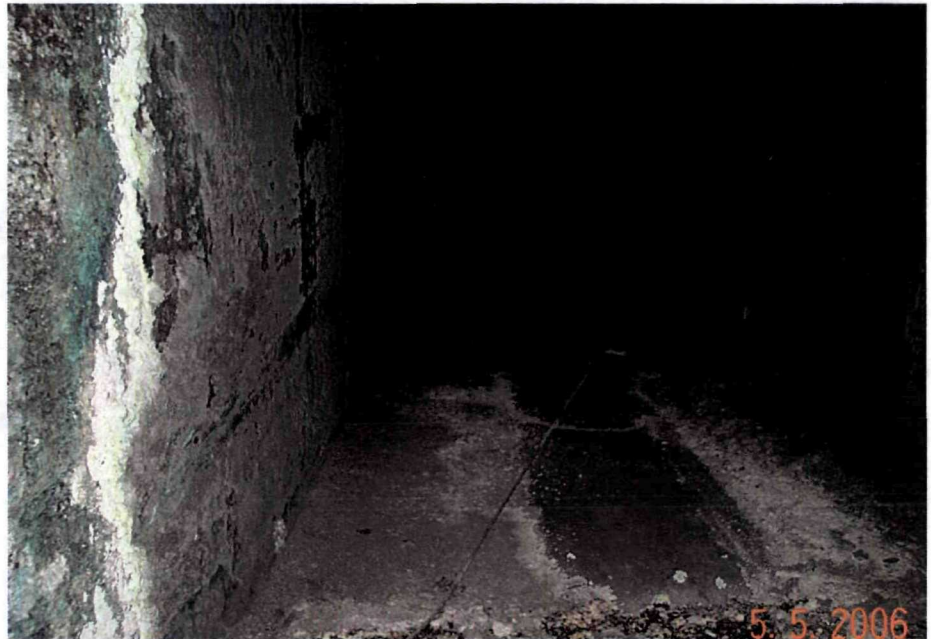
PHOTO #: ASARCO\_06125-008

Standing at the juncture of the Long and Short Speiss Pit looking into the Speiss (Short) Pit.

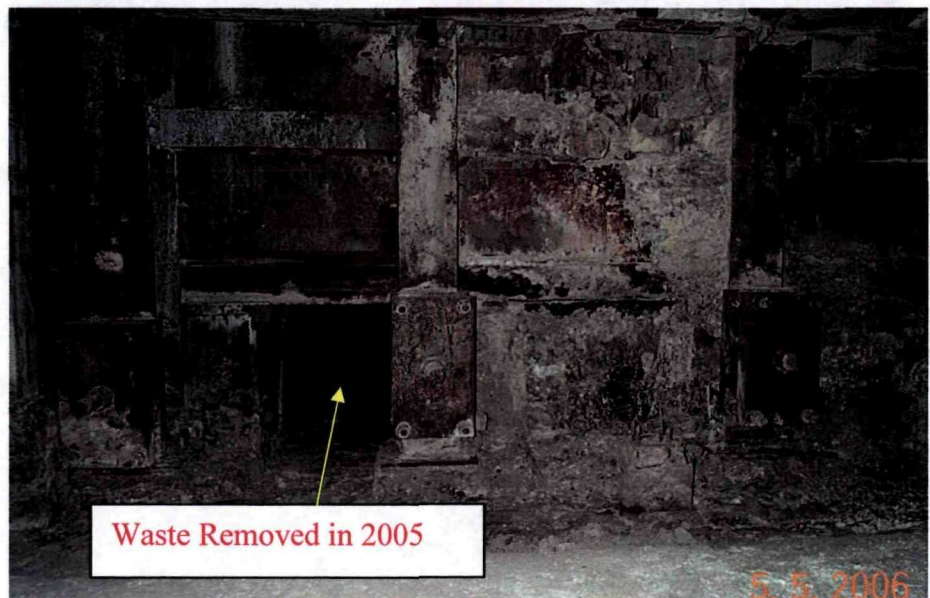
PHOTO #: ASARCO\_06125-009

Close-up of the backside of the Reverb Furnace in the Dross Plant looking from the Speiss Pit.

Note the accumulated lead residue waste that still remains under the furnace to the right of the photo.

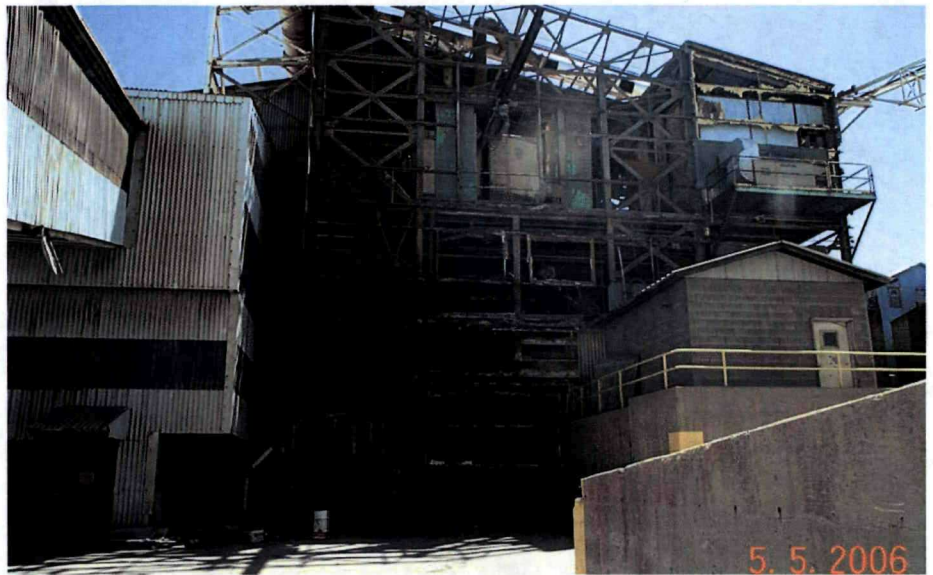
PHOTO #: ASARCO\_06125-010

Overall view of the West wall of the Sinter Plant with most of the transit paneling removed. The roof panels are still in place for the most part.

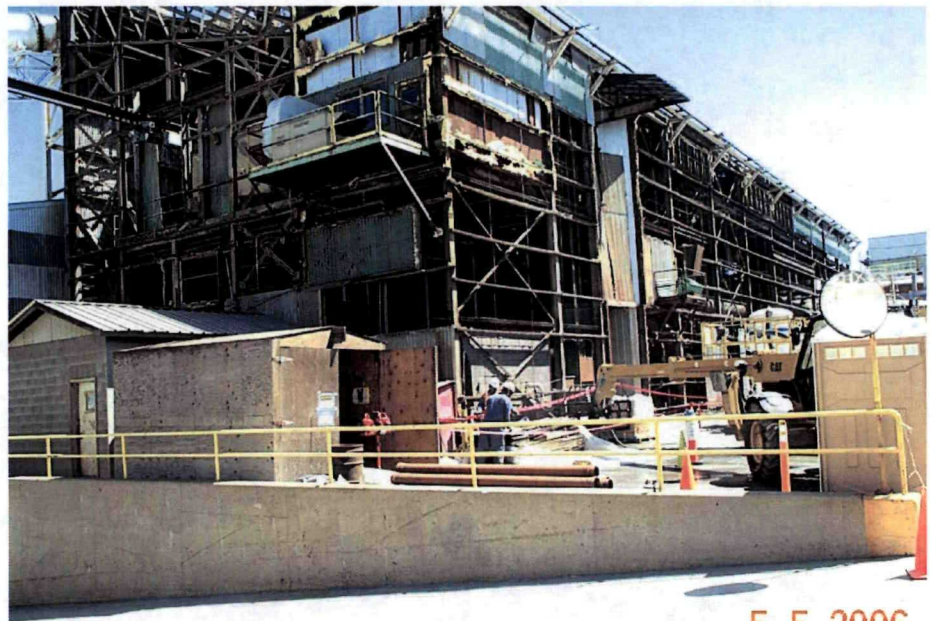
PHOTO #: ASARCO\_06125-011

Overall view of the South wall of the Sinter Plant during demo. The transite siding is collected in the area marked with red tape near the lower center of the photo.

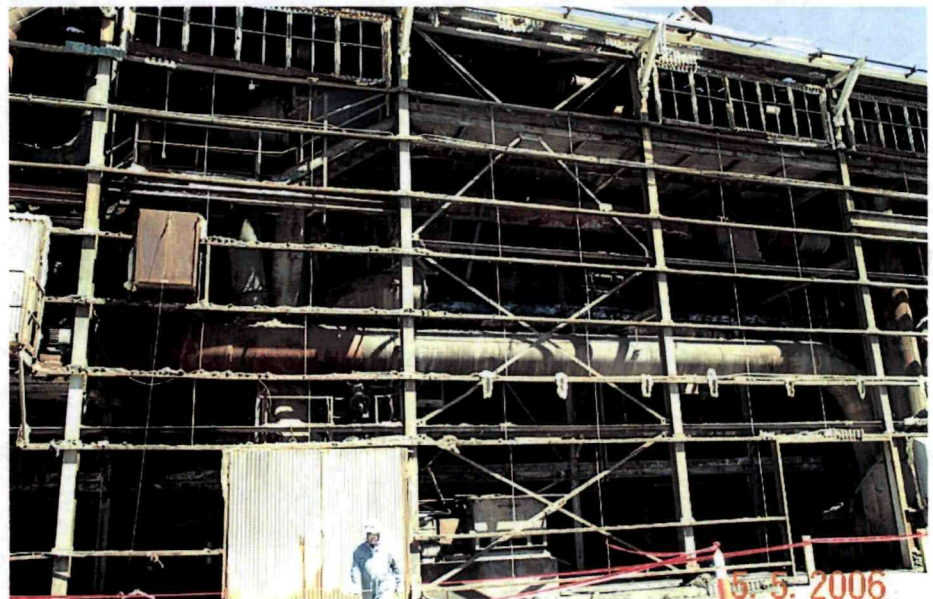
PHOTO #: ASARCO\_06125-012

Close-up of the exposed interior South wall of the Sinter Plant taken during demolition.

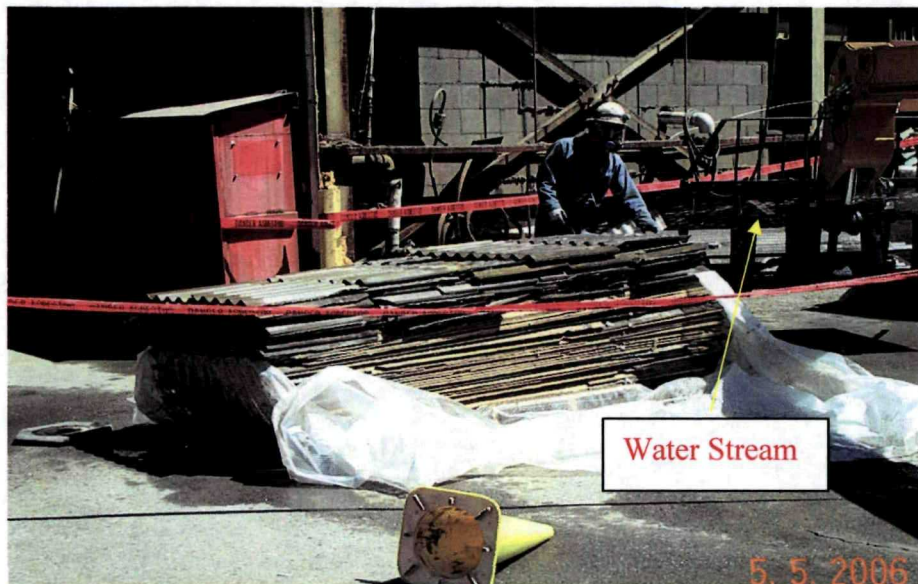
PHOTO #: ASARCO\_06125-013

Looking at the area where ACM (Transite siding) is bundled up, wetted down, and "burrito wrapped" at the southwest corner of the Sinter Plant.

Note the stream of water coming in from the right of the photo to suppress ACM emissions.

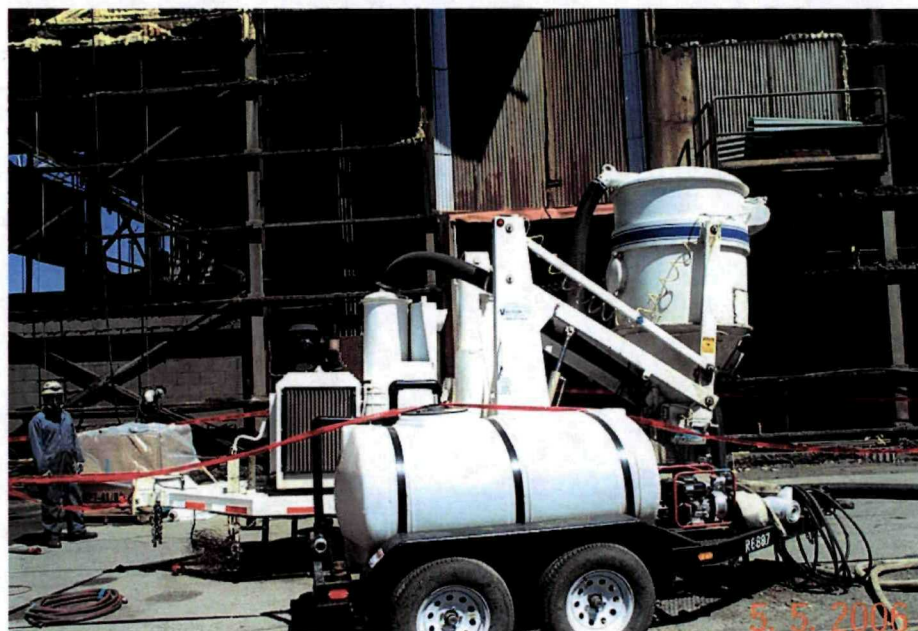
PHOTO #: ASARCO\_06125-014

Vacuum trailer used to sweep and vacuum ACM material at the Sinter Plant.

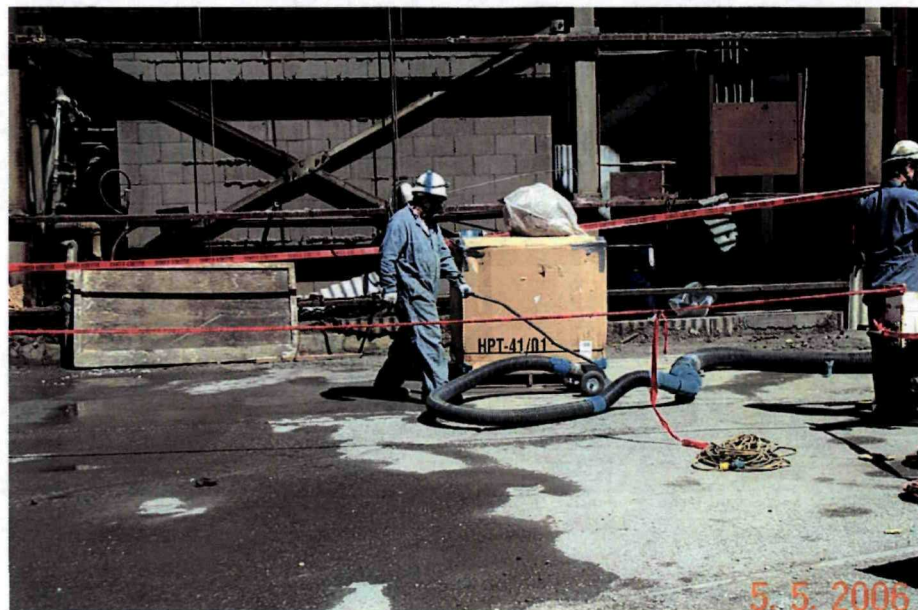
PHOTO #: ASARCO\_06125-015

Close-up of IRS technicians using the vacuum hose to collect loose ACM dust or particles after the bundle was moved to the Bailey building for interim storage.

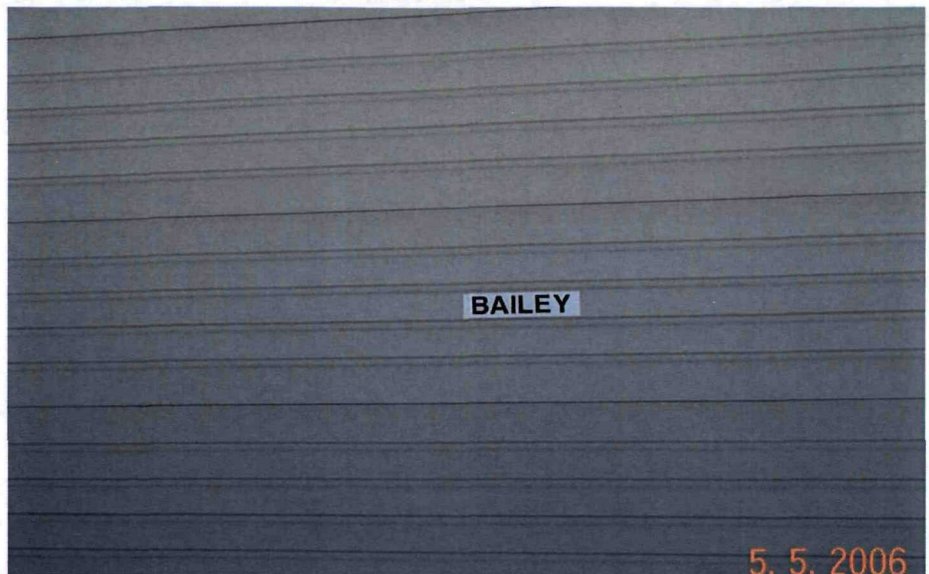
PHOTO #: ASARCO\_06125-016

Looking at the overhead door leading in the Coverall building called "Bailey" where the ACM is in interim storage.

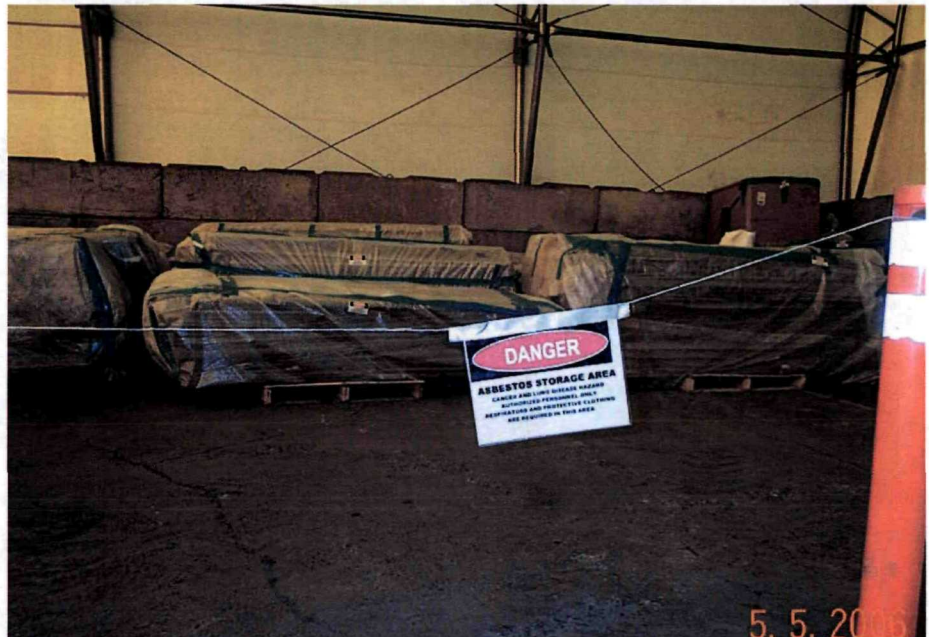
PHOTO #: ASARCO\_06125-017

After entering the Bailey building, the Asbestos material is stored in the Northwest corner of the building. The lego blocks are approximately six (6) feet high.

It appeared that proper signage was in use at the time of the inspection.

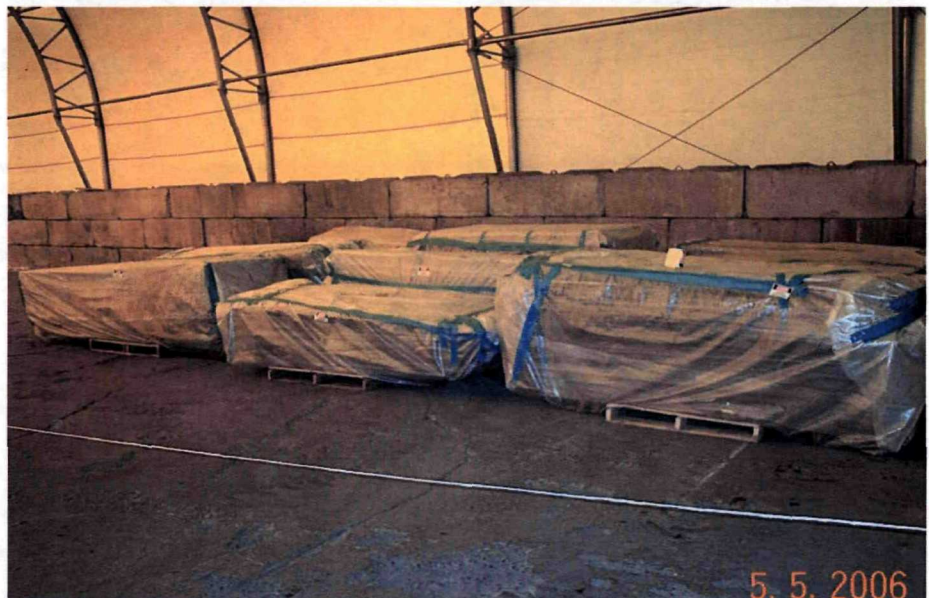
PHOTO #: ASARCO\_06125-018

Looking at some of the "burrito wrap" ACM in storage in the Bailey building.

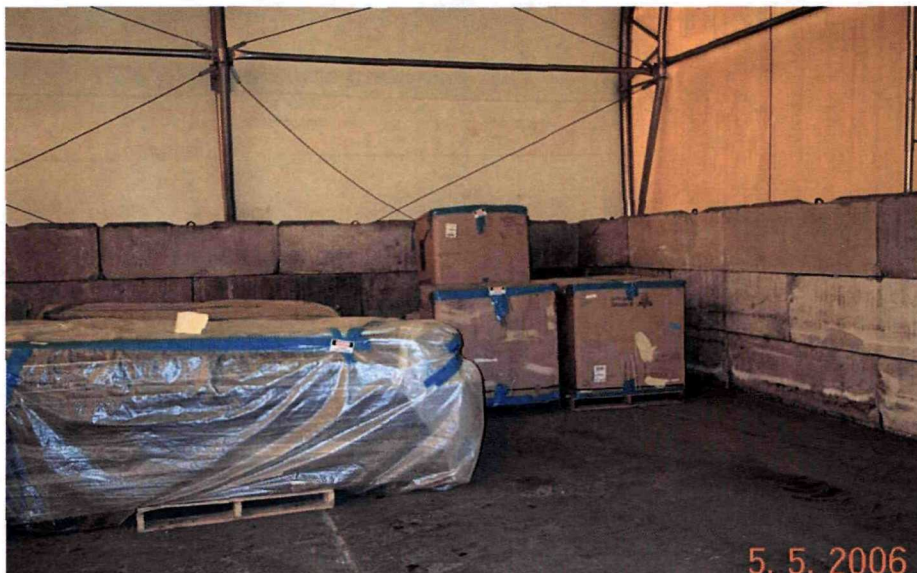
PHOTO #: ASARCO\_06125-019

Those small broken pieces of transite ACM paneling are collected in cardboard boxes also stored in the NW corner of the Bailey building.

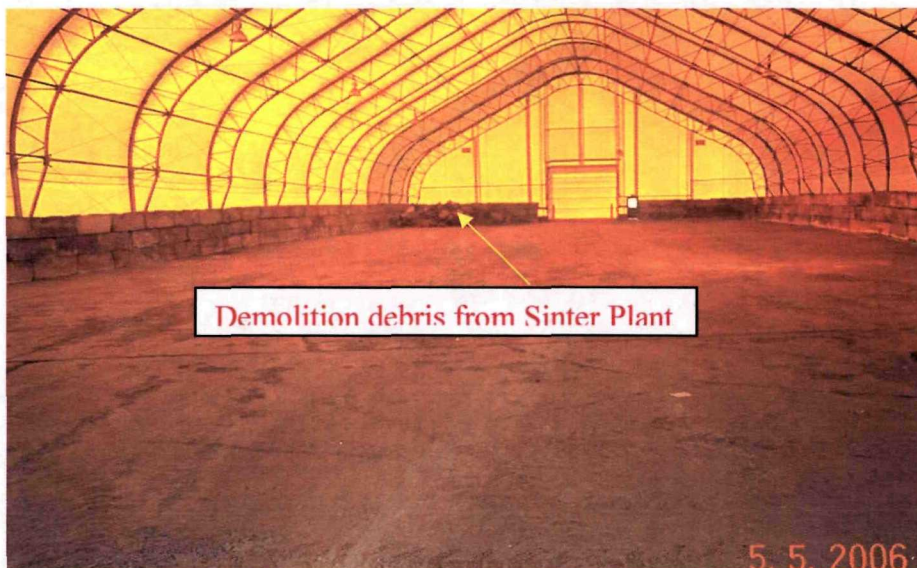
PHOTO #: ASARCO\_06125-020

Overall view of the Bailey building taken from the overhead door position. The ACM storage area is to the immediate right of the photo.

More demolition debris from the Sinter Plant is being collected in the far southeast corner of the Bailey building.

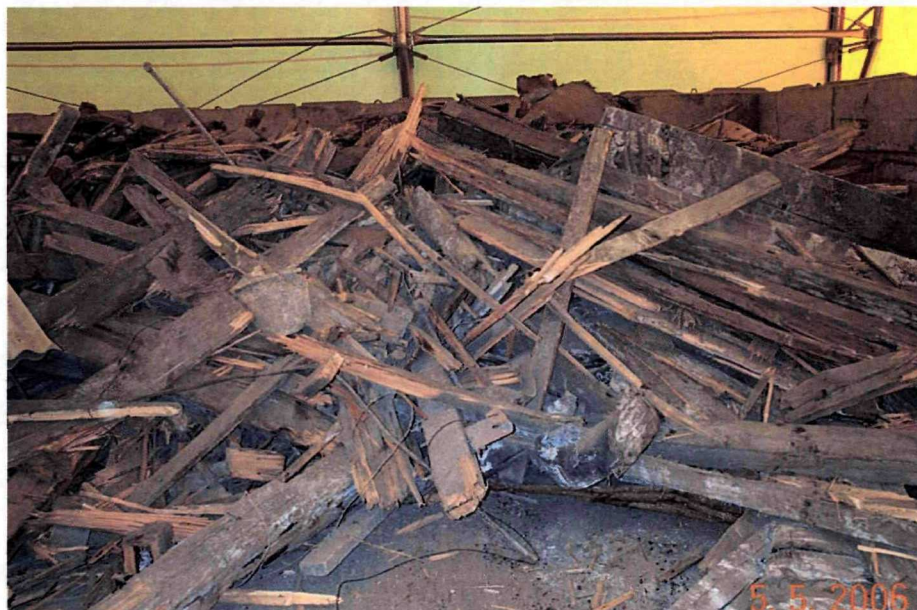
PHOTO #: ASARCO\_06125-021

Close-up of some of the demolition debris from the Sinter Plant being accumulated in the SE corner of the Bailey building.

Debris consists of wood, some non-recyclable metal, hoses, conveyor belts and non-ACM insulation.

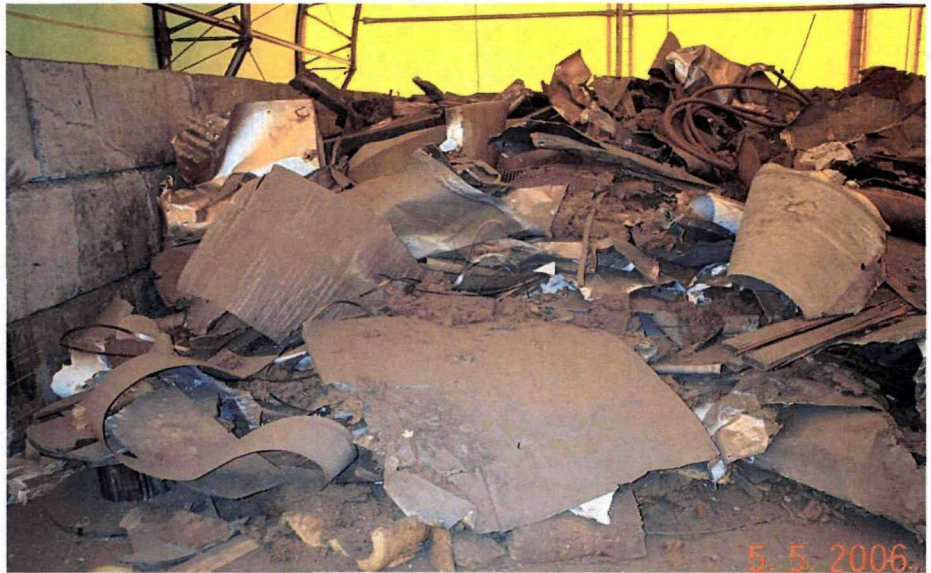
PHOTO #: ASARCO\_06125-022

Another close-up photo of some the Sinter Plant debris being accumulated in the Bailey building.

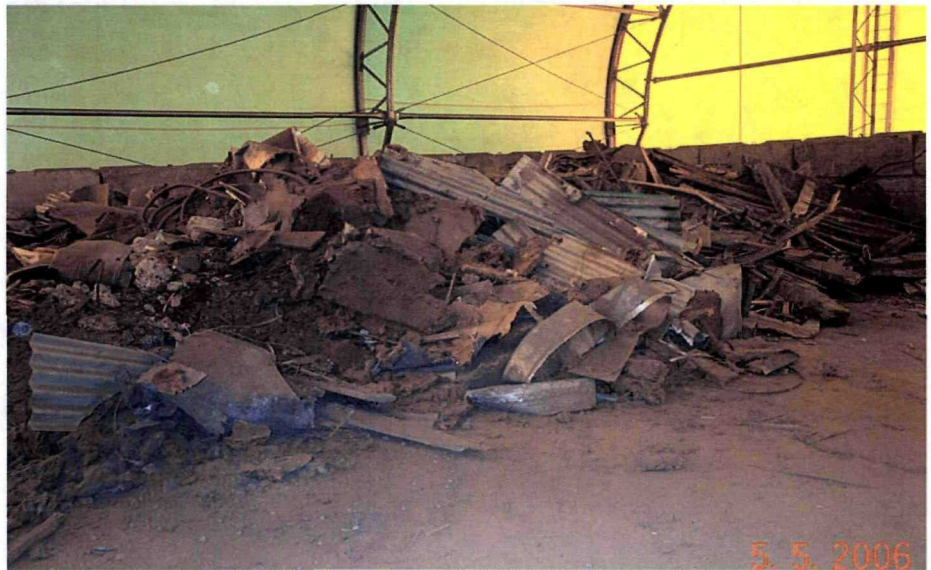
PHOTO #: ASARCO\_06125-023

Another look of the demolition debris stored in the Bailey building on an interim basis. This type of debris is destined for disposal in the CAMU.

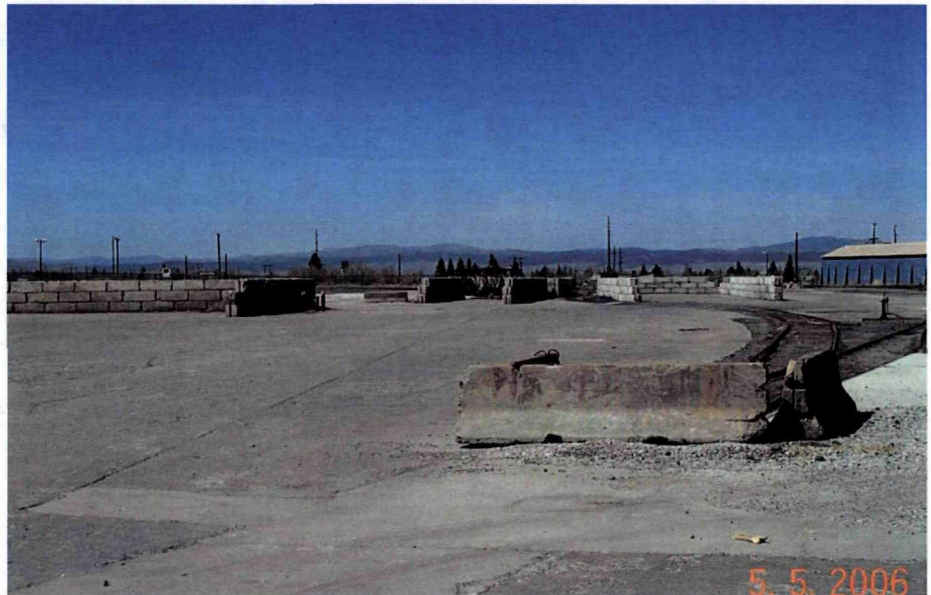
PHOTO #: ASARCO\_06125-024

Outside and to the Northwest of the Bailey building is the steel lay-down area. All recyclable scrap steel from all the demo work will be stored at this location prior to loading onto flatbed railcars brought into the plant on the tracks shown in this photo.

Note: Concrete debris from all the demolition activities is going to be stored in the CSHB at the time of this inspection.

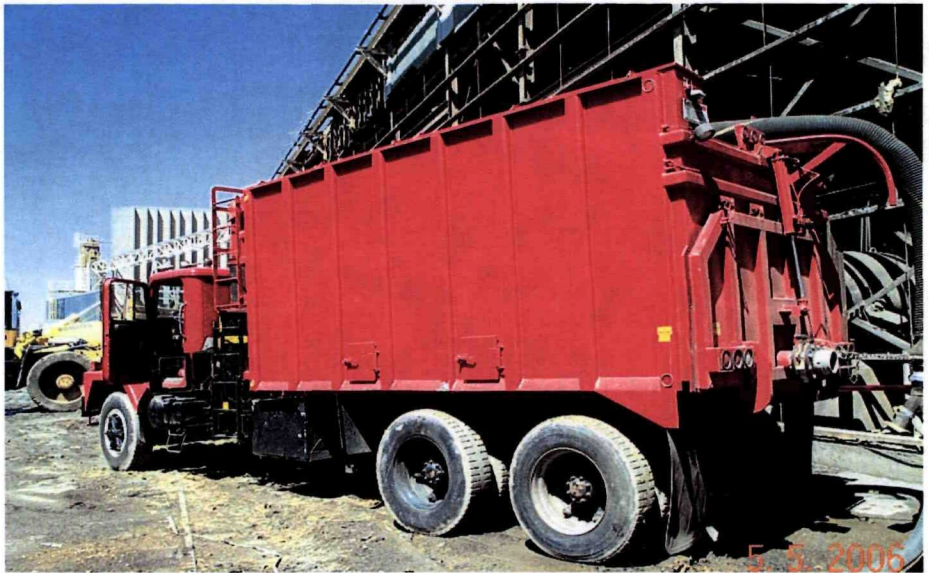
PHOTO #: ASARCO\_06125-025

Photo shows the type of vacuum truck used by demolition contractors to sweep and vacuum lead residue dust from inside ventilation ducts, floors and ledges at the Sinter Plant.

The dust is collected into plastic bags. The bag collection canister is located on the front of the box.

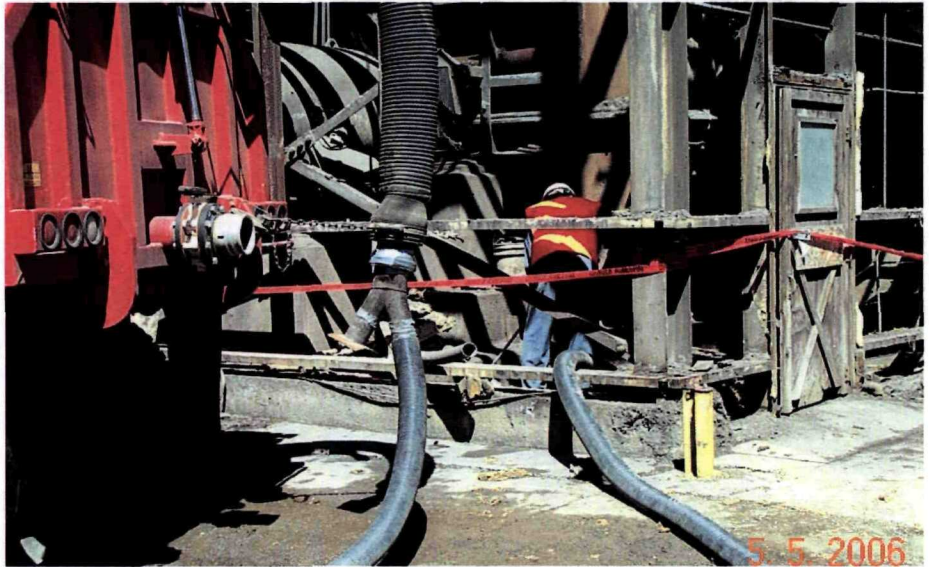
PHOTO #: ASARCO\_06125-026

Close-up of contract worker collecting residue and other dust from the floor of the Sinter Plant using the vac truck. The door into the east side of the Sinter Plant is shown in the photo.

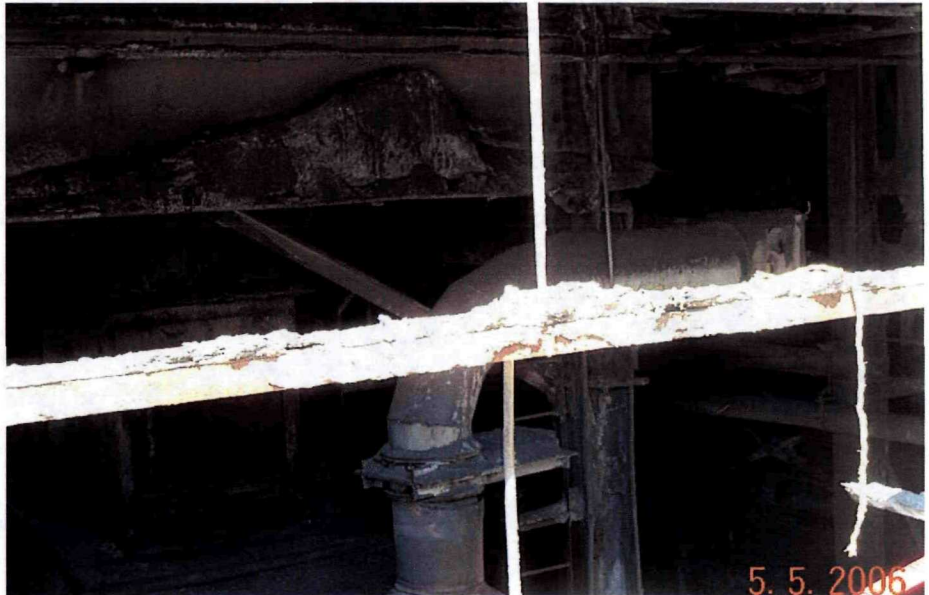
PHOTO #: ASARCO\_06125-027

This photo shows some of the lead residue remaining on the ledges after the transite siding has been removed at the Sinter Plant east wall.

It appeared that this residue was hard and not prone to be blown away with the wind.

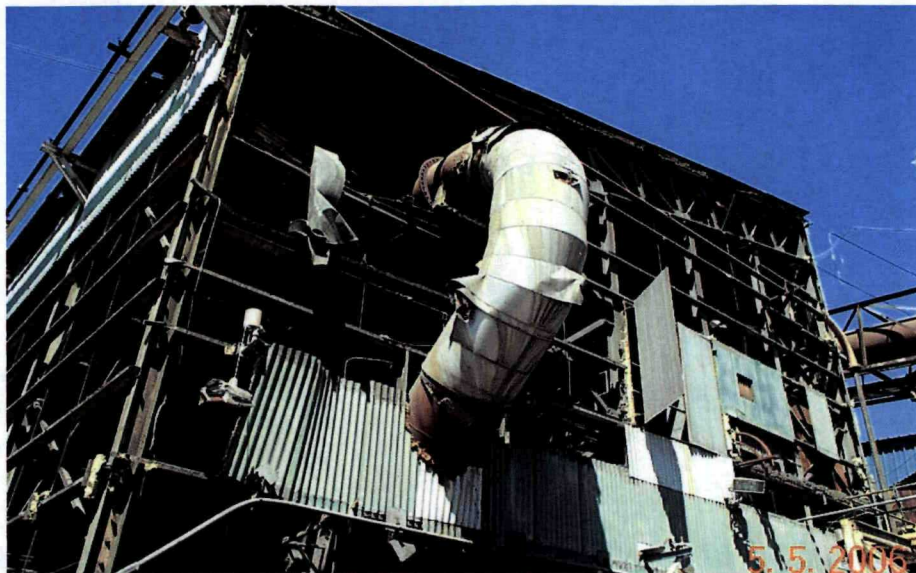
PHOTO #: ASARCO\_06125-028

This photo gives the viewer an idea how much vent work and remaining transite paneling is on the east side of the Sinter Plant at the time of the inspection.

It appears that most of the vent work and interior framework demolition will begin at the east end of the building.

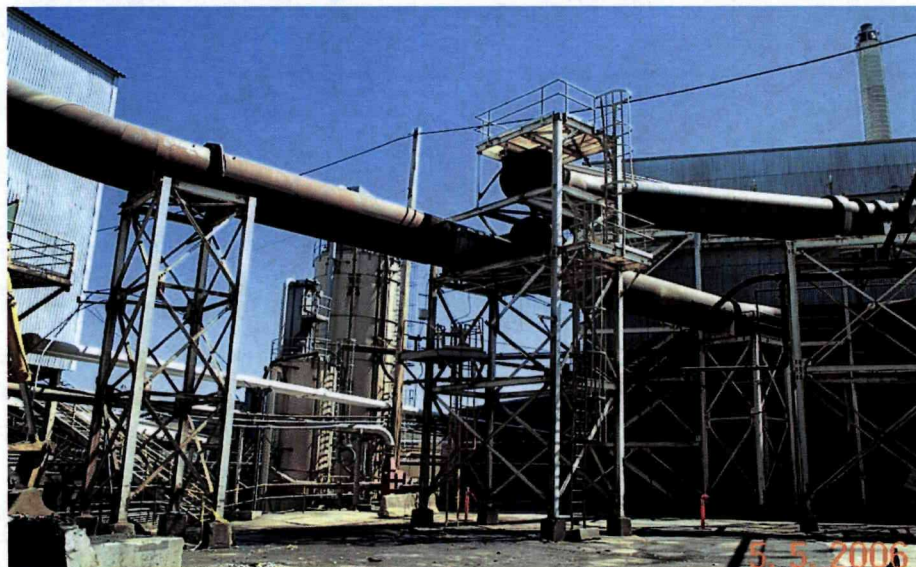
PHOTO #: ASARCO\_06125-029

This photo shows some of the remaining duct work on the east side of the Sinter Plant that needs to be dismantled before the building comes down.

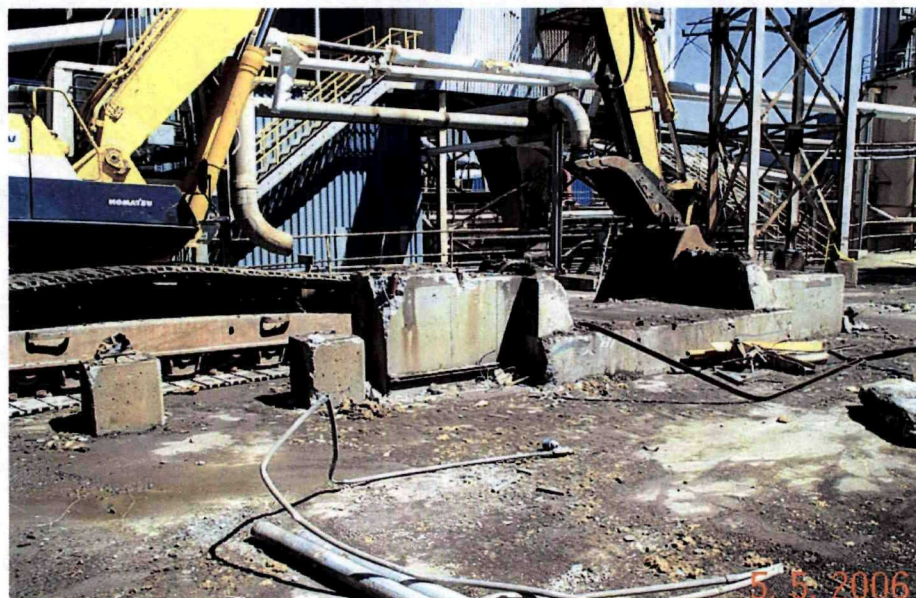
PHOTO #: ASARCO\_06125-030

After small adjacent buildings to the Sinter Plant have been demolished the foundation and footings remain.

The current contract does not call for removal of this type of debris.

According to Asarco personnel another contract will have to be put into place to remove this type of obstructions in order to place a cap over the entire footprint once all the buildings are removed.

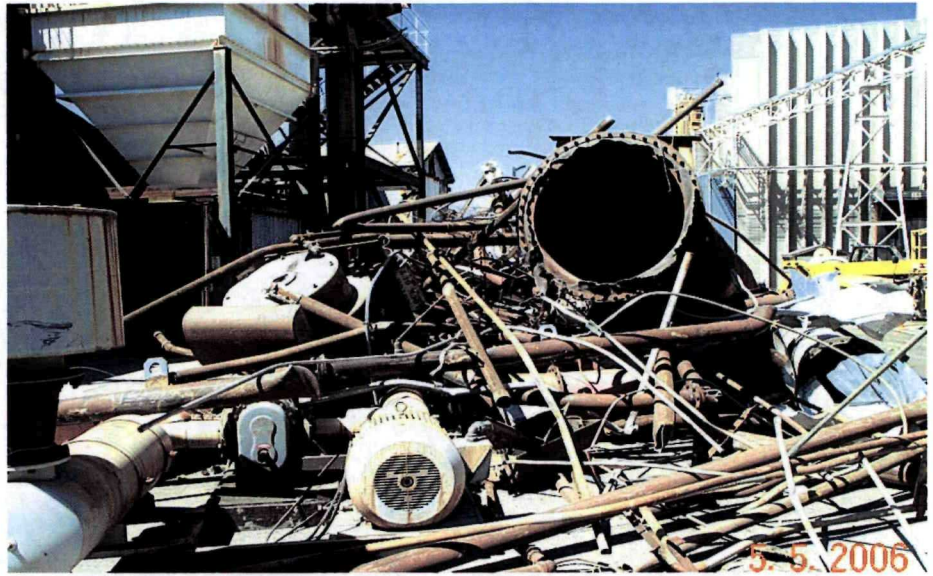
PHOTO #: ASARCO\_06125-031

This pile of scrap metal from the Sinter Plant is destined for recycling and represents some of the type of metal going out on flatbed railcars in the future.

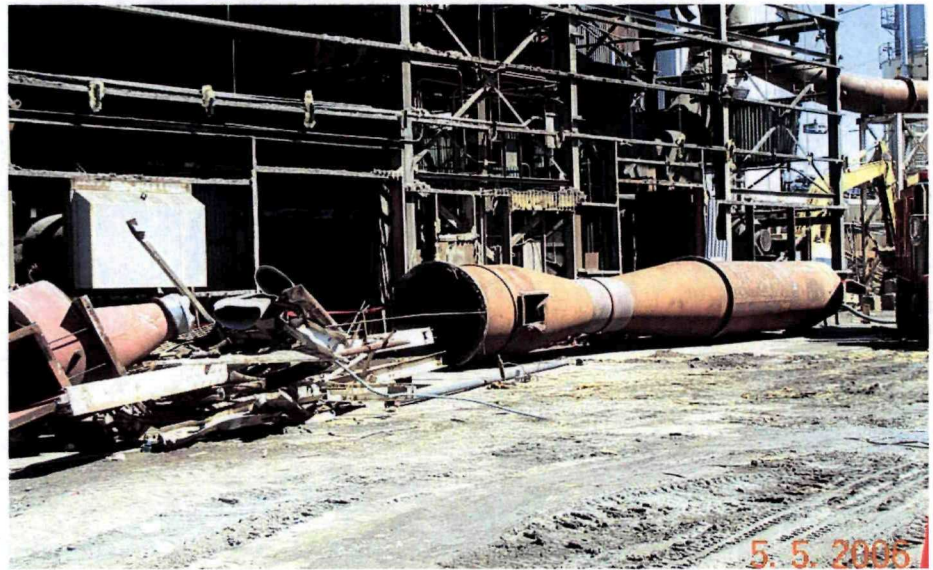
PHOTO #: ASARCO\_06125-032

Another view of scrap metal removed from the Sinter Plant.

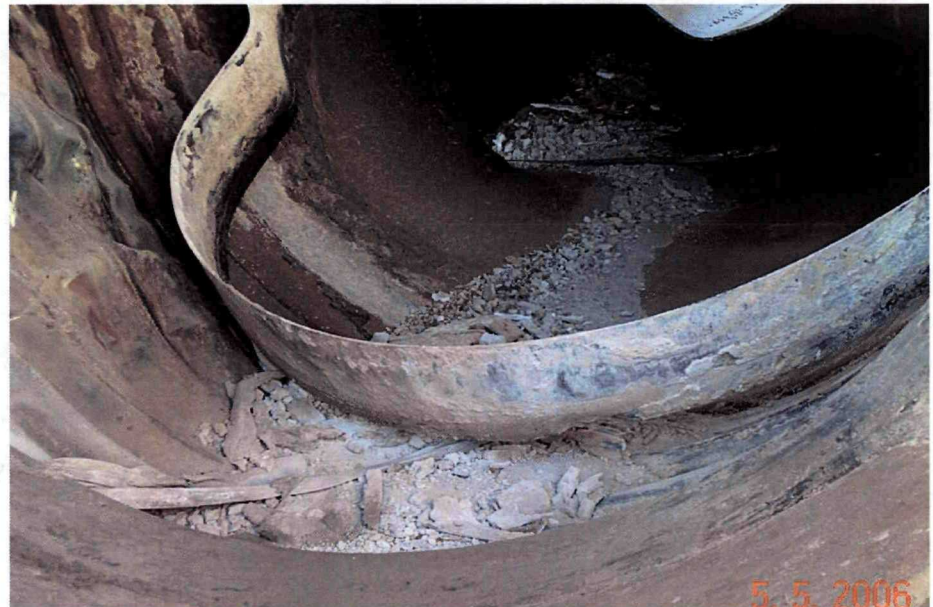
PHOTO #: ASARCO\_06125-033

Upon closer look into the ventilation ductwork, I observed lead residue that was in the bottom of this particular duct.

I was assured by Asarco and Envirocon personnel that this type of waste would be vacuumed up prior to placement in the scrap metal lay-down area northwest of the Bailey building.

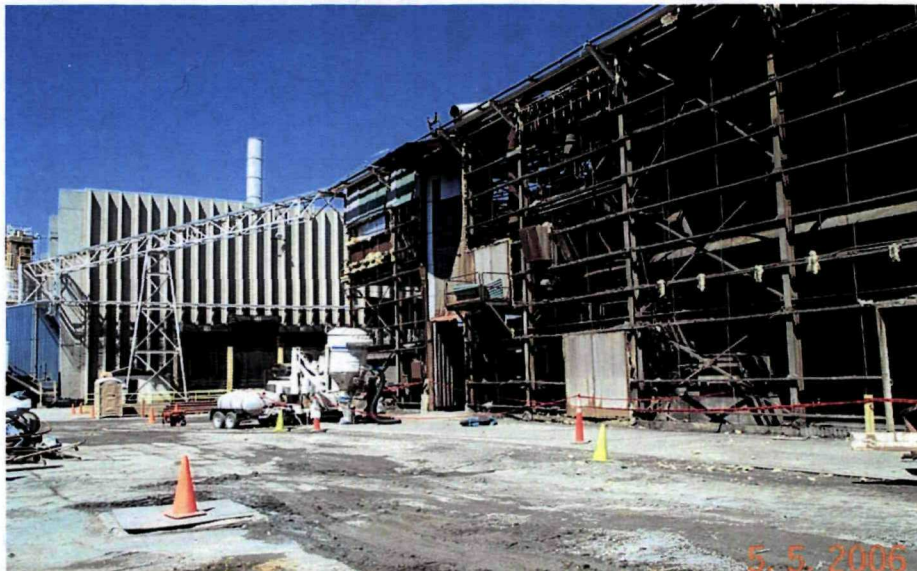
PHOTO #: ASARCO\_06125-034

This photo shows an area south of the Sinter Plant used to wash the interior of small duct work and piping with water. The water/residue mix is captured via the vac truck as it leaves the duct or pipe and stored in plastic bags.

The moist area, seen here in this photo, was a dust control event that occurred during the inspection.

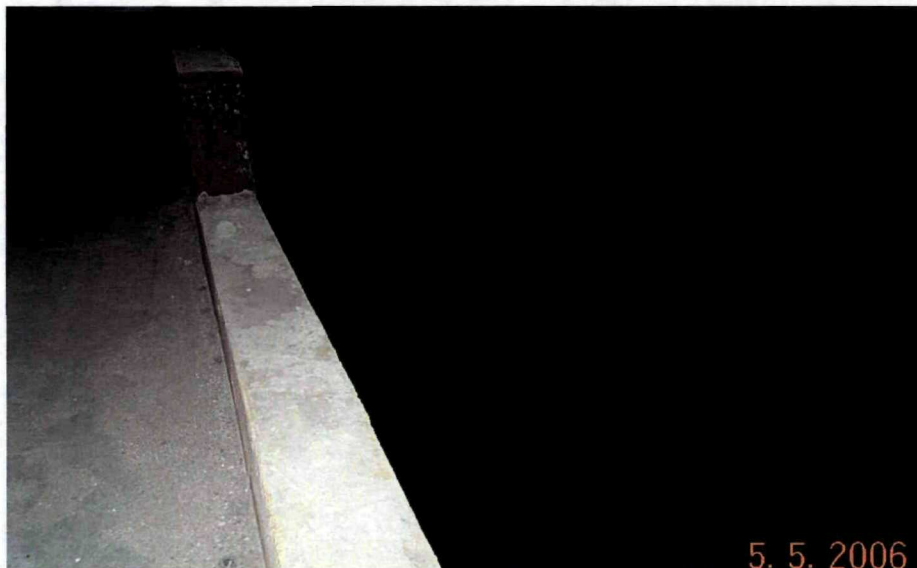
PHOTO #: ASARCO\_06125-035

The Truck bin is approximately 30-35 feet deep and approx. 25 feet across.

It has been suggested that Asarco use this Truck bin to store waste destined for the CAMU along with the Track bin and I-Bin in the CSHB.

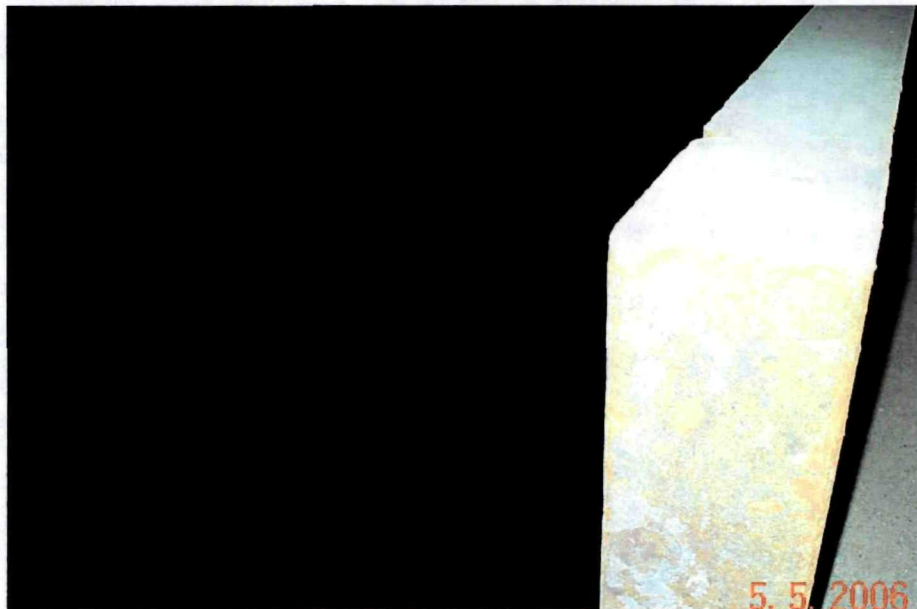
PHOTO #: ASARCO\_06125-036

Another view of the Truck Bin looking east. The concrete wall to the right center of the photo will be demolished to allow trucks to dump CAMU material into the bin after building a ramp leading down onto the floor of the bin.

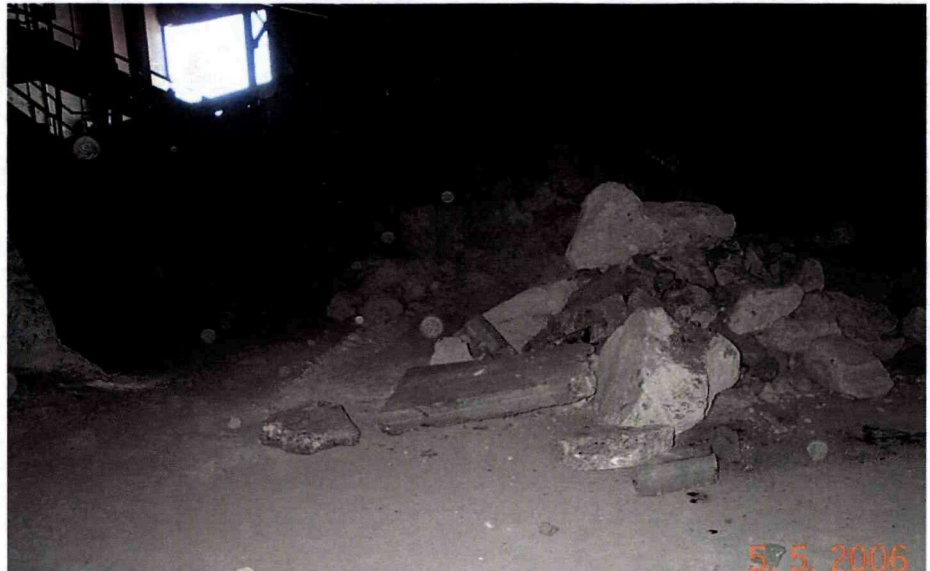
PHOTO #: ASARCO\_06125-037

This photo shows limerock, used to soak up Acid Plant sludge from the acid tanks, currently stored in the southwest corner of the I-Bin.

Asarco personnel asked the Department to consider placing this material into the CAMU.
